# **HONDA** Service Bulletin

01-038

Applies To: 2000-01 \$2000 - ALL March 27, 2001

# **Convertible Top Cover Comes Loose**

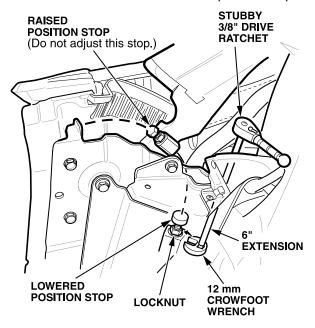
The stops that determine the convertible top's lowered position are adjusted too high.

4. Using a stubby 3/8" drive ratchet (with a 4" handle), a 6" extension, and a 12 mm crowfoot wrench, loosen the locknut on the lowered position stop.

5. Turn the locknut six turns counterclockwise, then turn the lowered position stop five turns clockwise.
